Contract #: 04-0120F4Cty: SF/ALA Rte: 80 PM: 13.2/13.9File #: 13.28**WELDING INSPECTION REPORT****Resident Engineer:**Pursell, Gary**Address:** 333 Burma Road**City:** Oakland, CA 94607**Report No:** WIR-011074**Date Inspected:** 05-Jan-2010**Project Name:** SAS Superstructure**OSM Arrival Time:** 1000**Prime Contractor:** American Bridge/Fluor Enterprises, a JV**OSM Departure Time:** 1830**Contractor:** Oregon Iron Works Clackamas, Or.**Location:** Clackamas, OR**CWI Name:** M. Gregson, J. Salazar**CWI Present:** Yes No**Inspected CWI report:** Yes No N/A**Rod Oven in Use:** Yes No N/A**Electrode to specification:** Yes No N/A**Weld Procedures Followed:** Yes No N/A**Qualified Welders:** Yes No N/A**Verified Joint Fit-up:** Yes No N/A**Approved Drawings:** Yes No N/A**Approved WPS:** Yes No N/A**Delayed / Cancelled:** Yes No N/A**Bridge No:** 34-0006**Component:** Hinge K Pipe Beams**Summary of Items Observed:**

Hinge-K Pipe Beam Assembly 102A-3**a111-3 Forging to a110-3 Base Plate**

Hinge-K Pipe Beam Assembly 102A-1**a111-1 Forging to a110-1 Base Plate**

Hinge-K Pipe Beam Fuse Assembly 120A-6

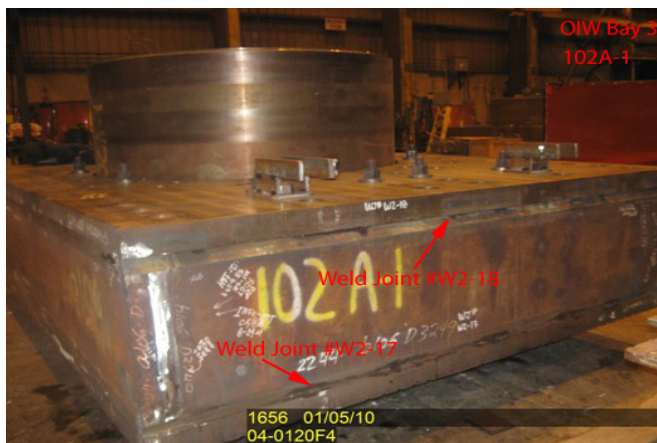
The QA Inspector noted that OIW welder # O6, Mr. Tim O'Brian was continuing to blend the weld start/stops, removing weld spatter and grinding all areas, which were previously marked by OIW QC Inspectors. The QA Inspector noted that these areas were on the previously completed submerged arc welded (SAW), HPS 485W stiffeners, designated as weld joints #W1-01 thru W1-163. The QA Inspector spoke with QC Inspector Jose Salazar and Mr. Salazar explained that the visual clean-up that was being performed by Mr. O'Brian, was intermittently monitored and areas that were completed, were then visually re-inspected. See attached picture below.

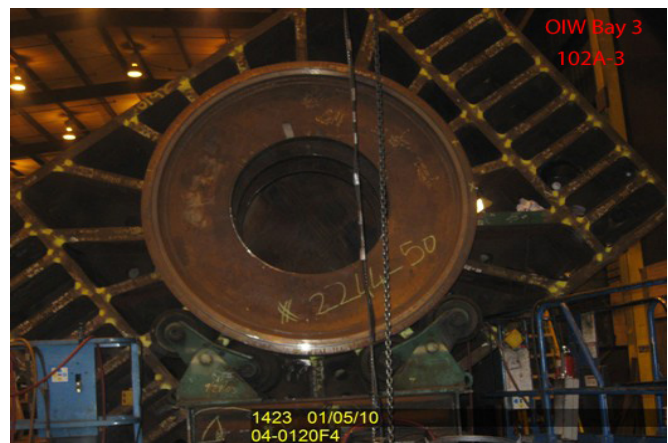
On this date,the QA Inspector was notified by QC Inspector Jose Salazar that the partial penetration welds (PJP's), designated as weld joints #W2-01 and W2-02 were completed. QC Inspector Salazar notified the QA Inspector that welder #T23, Mr. John Tellone, was currently grinding off excessive reinforcement on the completed welds. Mr. Salazar explained that the reinforcement exceeded 1/8" (3mm), after measuring with a bridge cam gauge. Mr.

Salazar explained that the run-off tabs will then be cut off. QA Inspector later noted that the grinding was complete, run-off tabs cut off and witnessed OIW utilizing an overhead shop crane and slings and laying this assembly on the shop floor.

QC Inspector Salazar later explained to the QA Inspector, OIW will pick this assembly up and place in the welding positioner. Mr. Salazar explained that the submerged arc welding on weld joints #W2-17 and W2-18 will then start. The QA Inspector noted that these were the last two partial penetration (PJP) weld joints on the a109 Cap Plate/a110 Base Plate to ab106/a106 and b106 stiffeners. See attached picture below.

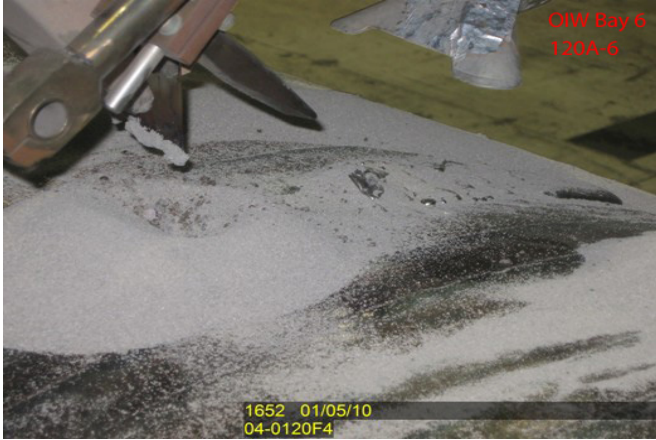
a124-14 Half Fuse to a124-2 Half Fuse

The QA Inspector was notified by QC Inspector Jose' Salazar that OIW had previously received additional shipment of 316L and OIW will continue the Electroslag Welding (ESW), on this Fuse 120A-6. The QA Inspector noted that the ESW on the Fuse had previously remained idle from 10/1/09 thru 1/4/10, pending the shipment of additional 316L stainless steel strip. The QA Inspector witnessed OIW welder #F17, Mr. Igor Frolov, a helper and welding Lead Troy Smith performing various adjustments to the submerged arc welding (SAW) machines, in preparation for the ESW welding. The QA Inspector spoke with Lead Troy Smith and Mr. Smith explained that the amperage, voltage and travel speed adjustments were being performed, prior to commencement of the ESW, per welding procedure specification (WPS) 7003. The QA Inspector noted that OIW had also previously set-up a stationary torch, for the continuous pre-heat, during the ESW process. The QA Inspector noted that approximately 25% of the third and final layer of 316L had been previously completed and OIW was setting up to finish the remaining 75% 316L. The QA Inspector noted that at end of shift, OIW had performed a trial run of ESW. The QA Inspector noted that the trial run was not successful and OIW will have to continue the adjustments, prior to successfully performing the ESW. See attached picture below.
